Radiographic Outcome of Vital Teeth Treated with Prosthodontic Crowns in Dogs: 26 Cases (2015-2017)

Journal of Veterinary Dentistry
2024, Vol. 41(5) 382-386
© The Author(s) 2023
Article reuse guidelines:
sagepub.com/journals-permissions
DOI: 10.1177/08987564231208045
journals.sagepub.com/home/jov

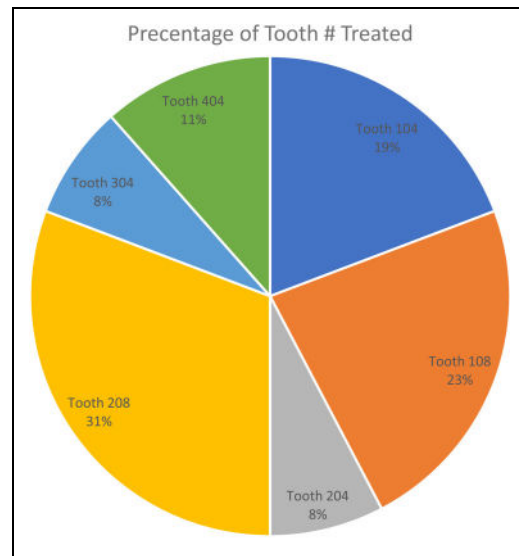
Figure 1. Percentage of teeth which received full metal titanium alloy crowns. Tooth 208 had the highest incidence of damage compared to teeth 204 and 304, whose incidence was only 8%. Abbreviations: 104, Right maxillary canine tooth; 108, Right maxillary fourth premolar tooth; 204, Left maxillary canine tooth; 208, Left maxillary fourth premolar tooth; 304, Left mandibular canine tooth; 404, Right mandibular canine tooth.

Of the 17 dogs in the study and the 26 full metal crowns, 21 crowns were placed on maxillary teeth and 5 placed on mandibular teeth. Twelve teeth which received treatment were canines and 14 were maxillary fourth premolars (Figure 1). The recommendation and reason for a full metal crown were due to abrasion (3), uncomplicated crown fracture (10), uncomplicated crown-root fracture (2), enamel hypoplasia (2), cage biting abrasion (4), and vital pulp therapy (5) (Figure 2). There was one case which had a full coverage crown placed that developed periapical lucency (PAL) at the time of follow-up. This was marked as the only non-successful case by 3 of the 4 reviewers. EIRR was noted in 5 of the treated teeth and was unchanged on recheck radiographs. Twenty-five of 26 teeth which were treated with prosthodontic full metal crowns remained vital (Figures 3 to 6).

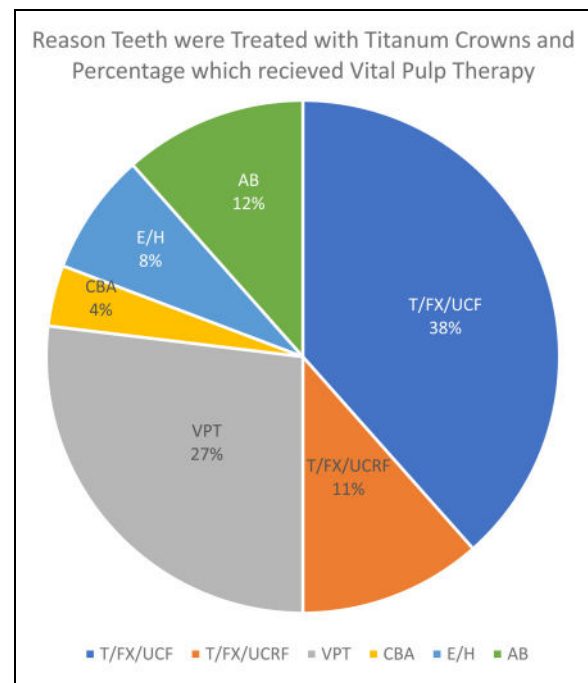
Figure 2. Percentage of teeth receiving titanium crowns by fracture or disorder type and percentage receiving vital pulp therapy. Uncomplicated crown fractures were the most prevalent. Abbreviations: AB, Abrasion; E/H, Enamel Hypoplasia; CBA, Cage Biting Abrasion; VPT, Vital Pulp Therapy; T/FX/UCRF, Uncomplicated Crown-Root Fracture; T/FX/UCF, Uncomplicated Crown Fracture.

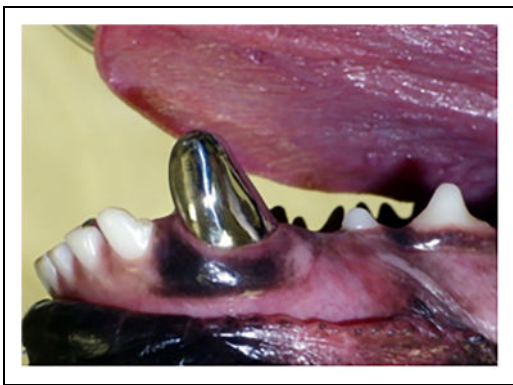
Figure 4. Photograph showing a full coverage metal alloy crown on tooth 304 1 year after crown cementation on a complicated crown fracture after treatment with vital pulp therapy (see Figure 5 for corresponding dental radiograph).

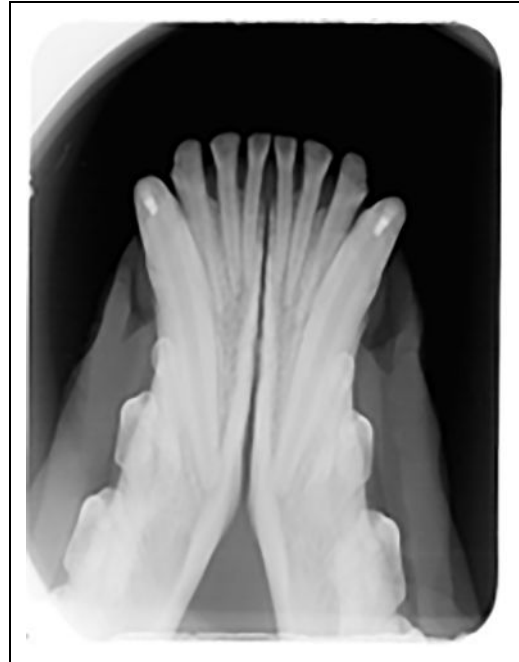
Figure 5. Radiograph of teeth 304 and 404 treated with vital pulp therapy due to cage biting abrasion. These teeth also received full coverage metal alloy crowns.

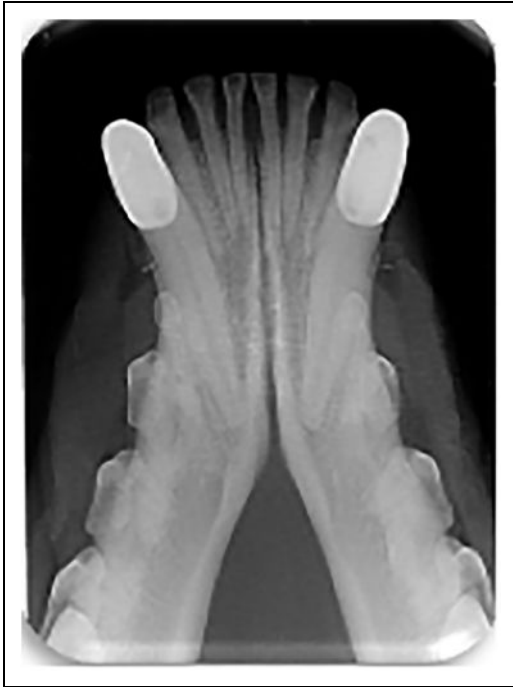
Figure 6. Radiograph of teeth 304 and 404 from Figure 5, 1 year after crown placement. These teeth continued to mature appropriately and therefore remained vital.
