Correction of Mesioverted Maxillary Canine Tooth in a Sheltie Dog

Author: Dr. Grace Brown, DVM, DAVDC

Written for the: Arizona Veterinary Medical Association, 2018

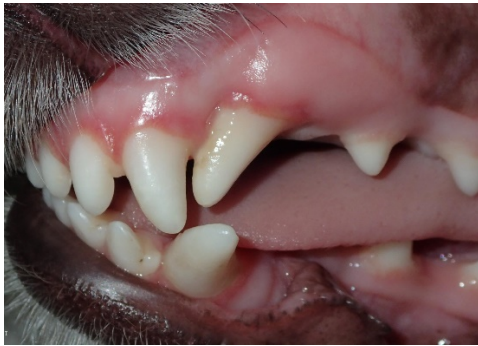
Figure 1: Photograph showing mesioversion of left maxillary canine tooth (204) in a dog. Note the tooth 204 is not impacted on the distal surface of the maxillary left third incisor tooth (203). There is increased gingivitis affecting 204 with the maxillary lateral incisor 203.

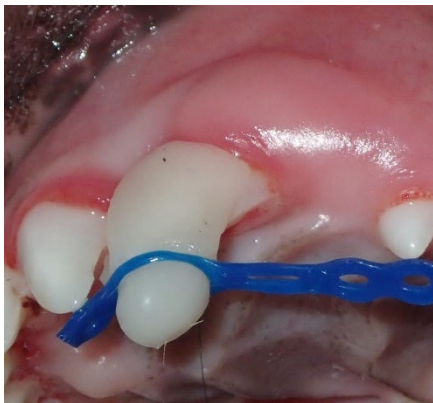
The tooth was acid etched and single bond was applied to the coronal aspect of 104 and light cured for 20 seconds. Z250 was molded to make a coronal button and light cured for 35 seconds. This will hold the elastic chain. This technique creates a coronal button on the surface of 104.

Figure 2: Photograph of the coronal button on 204 after elastic chain placement. A hook may be made out of 24 or 26-gauge wire which would be bonded in place on the coronal 1/3 of the maxillary canine tooth. However, make sure the hook is placed in the direction of the intended movement if this technique is used. This method is described in the JVD 2008 article by Loic Legendre, DVM.

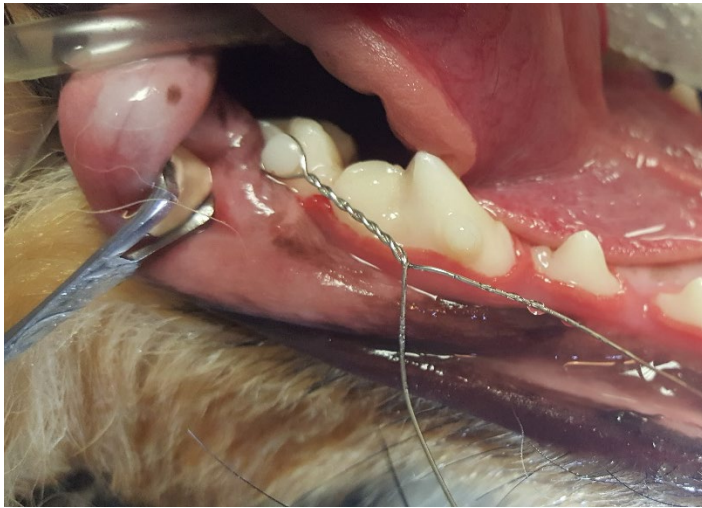
Figure 3: Photograph showing orthodontic buttons applied to the anchorage teeth. A lingual button which was made out of flowable restorative composite has been bonded to the cusp of the maxillary first molar tooth.

First, the 209 and 208 were acid etched for 15 sec and rinsed. An application of single bond was applied to the areas where the buttons would be placed, and light cured for 20 seconds. Then flowable restorative composite was applied and shaped into a button. This was light cured for 35 seconds. A diamond bur was used to create more of a round button.

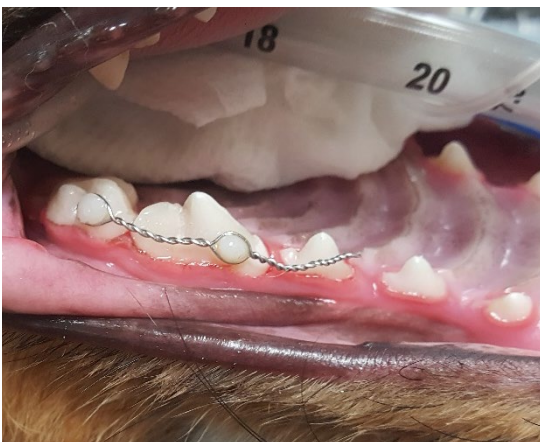
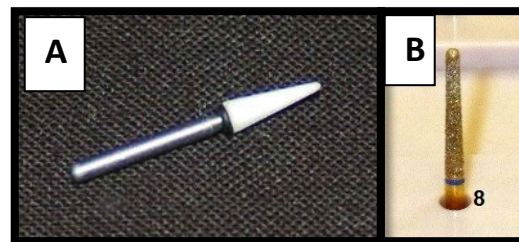
A: Arkansas stone; B: round end taper diamond (Goldie)

Figure 4: An orthodontic tie was twisted from the lingual button to the distal button connecting the teeth as a single anchorage unit. This was performed using 24 or 26-gauge wire. The wire continued to twist and was bent to form a hook at the mesiobuccal aspect of the tooth of the maxillary fourth premolar tooth.

The wire and teeth were acid etched and single bond was applied which was light cured for 20 sec. Flowable composite resin is added to the buccal surface of these teeth providing a tooth/wire/composite resin anchorage unit. Application of Protemp (maxi temp) was then applied over the flowable restorative composite and hook. Then teeth which was smoothed with a round end taper diamond (Goldie) and an Arkansas stone.

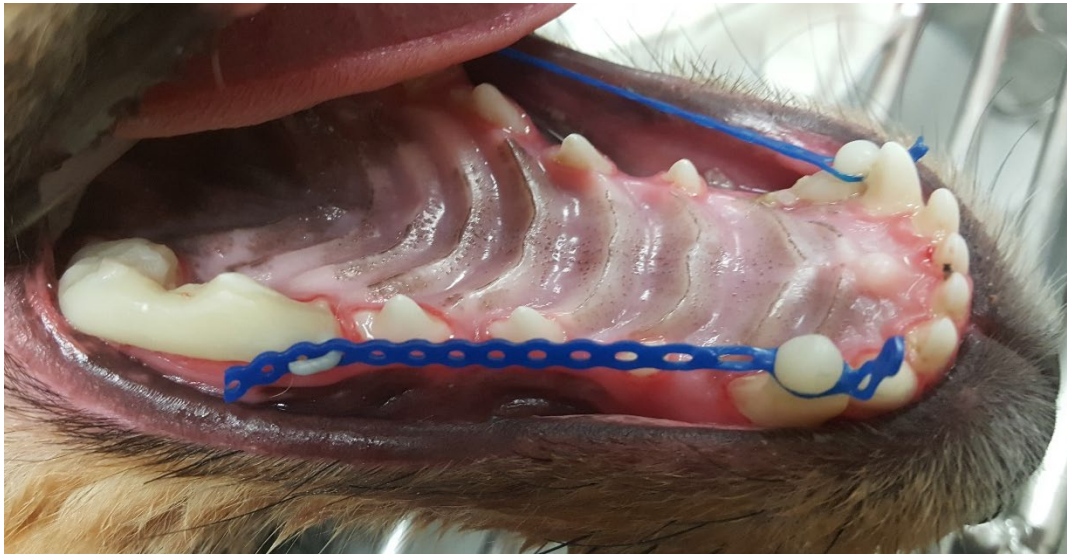
Figure 5: Photograph showing the completed application of the orthodontic appliance. An elastic Masel chain was attached to the coronal button and bracket and shortened approximately 75 to 80% of its resting length to achieve the appropriate tension force on the target tooth.

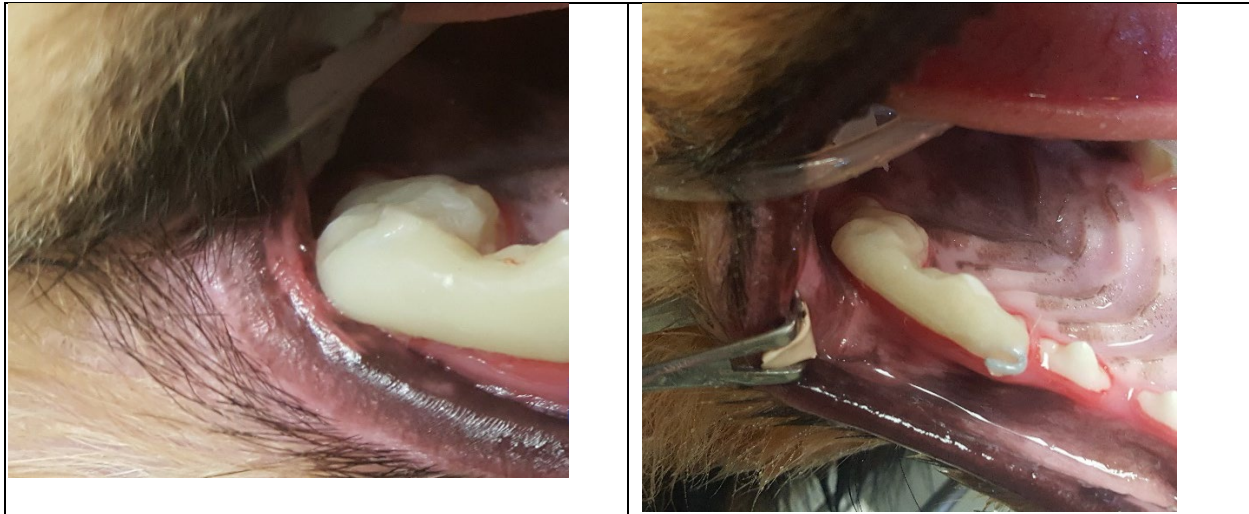
Figure 6: Photograph showing application of a bite block which was applied to the occlusal aspect of 109 and 110 to occlude from an interlock occurring as the teeth were correcting. This was applied with a similar technique as noted previously. Application of acid etch for 15 sec, rinsed then application single bond which was light cured for 20 sec. Then covered with Protemp which was smoothed. An application of universal bond was applied to the fully completed orthodontic appliance and then light cured to reduce gingival trauma.
